COUNTRY Eastern Austria SECURITY INFORMATION REPORTTOPIC Airfields in Austria

DATE PREPARED 28 October 1952

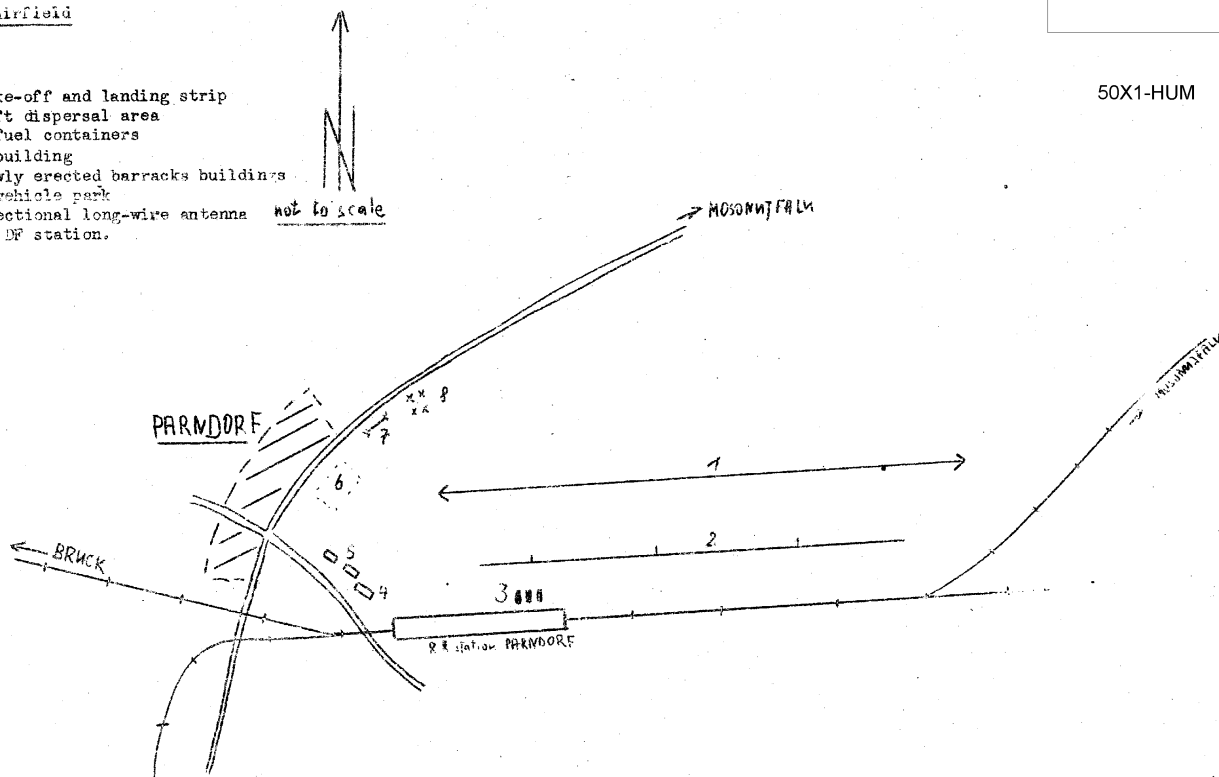
- (9) This is the first information that Parndorf airfield was enlarged to the east. The surrounding terrain is level and suitable for expansion. It is believed that the extended landing field was only rolled. For sketch of Parndorf airfield, see Annex.
